A BRAZING PROCESS FOR Cb-1Zr HEAT RECEIVER TUBES

by C. E. Smeltzer and W. A. Compton

Prepared under Contract No. NAS3-10603 by
SOLAR DIVISION, INTERNATIONAL HARVESTER COMPANY
San Diego, Calif.

for Lewis Research Center

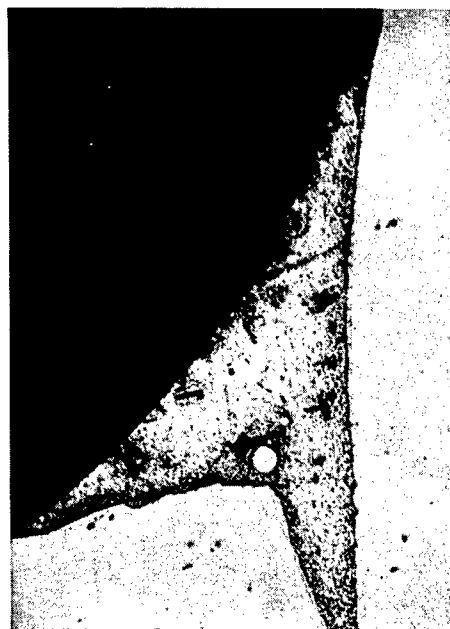
FIGURE 21. LAP-JOINT BRAZEMENTS OF Cu-2Ni BRAZE ALLOY

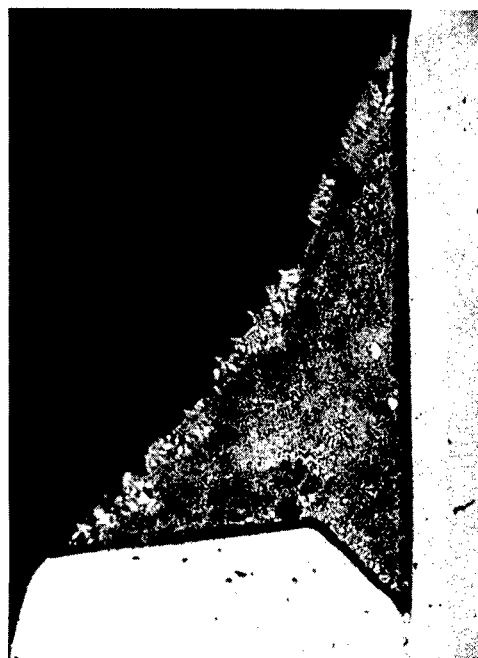
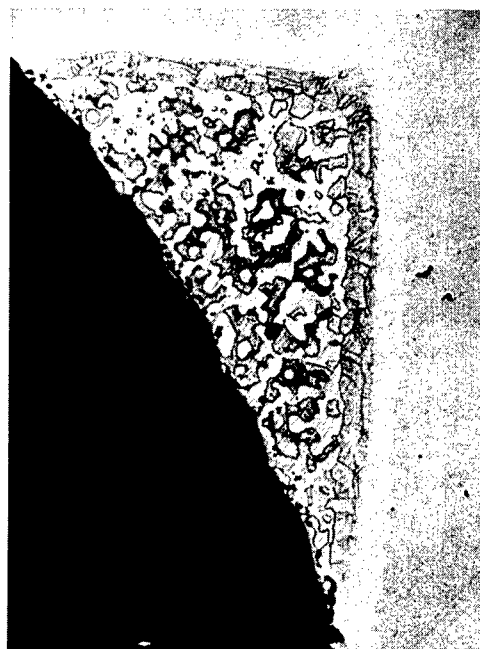
FIGURE 22. LAP-JOINT BRAZEMENTS OF Zr-28V-16Ti BRAZE ALLOY

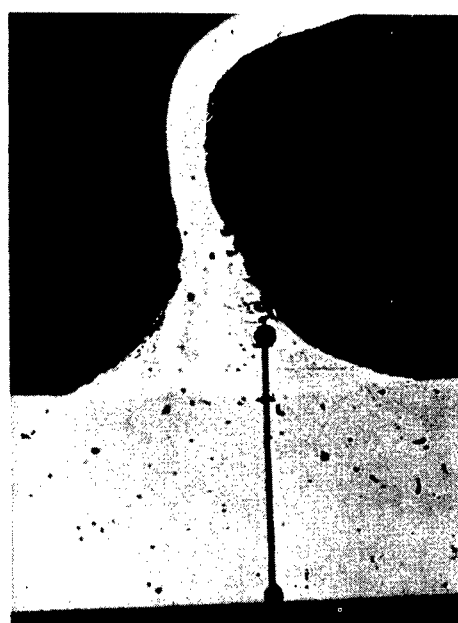
FIGURE 25. BRAZED T-JOINT SPECIMENS FOR MICROPROBE ANALYSIS;
Zr-28V-16Ti-0.1Be Braze Alloy

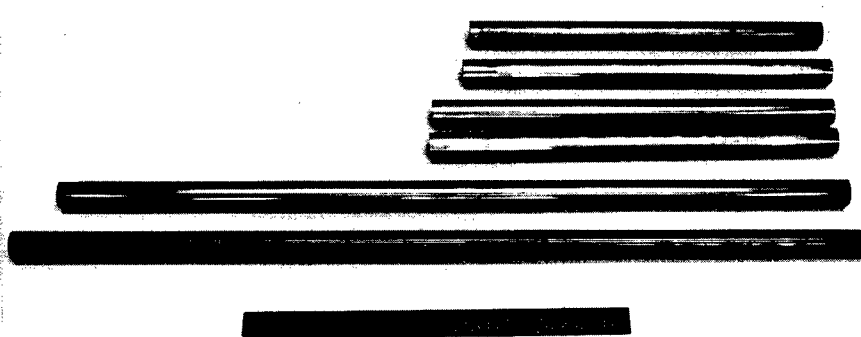
FIGURE 44. EXTERNAL SIDE VIEWS OF FOUR 18-INCH AND TWO 36-INCH HEAT RECEIVER TUBES; Post Brazing

The two brazed and inspected 36-inch tubes are shown in Figure 44. These full scale heat receiver tubes were later capped and sealed in polyethylene bags and shipped to the sponsor.
